Issued by
AIR MINISTRY A.C.A.S.(I).

VOLUME 4

JULY 5TH 1943

EVIDENCE IN CAMERA

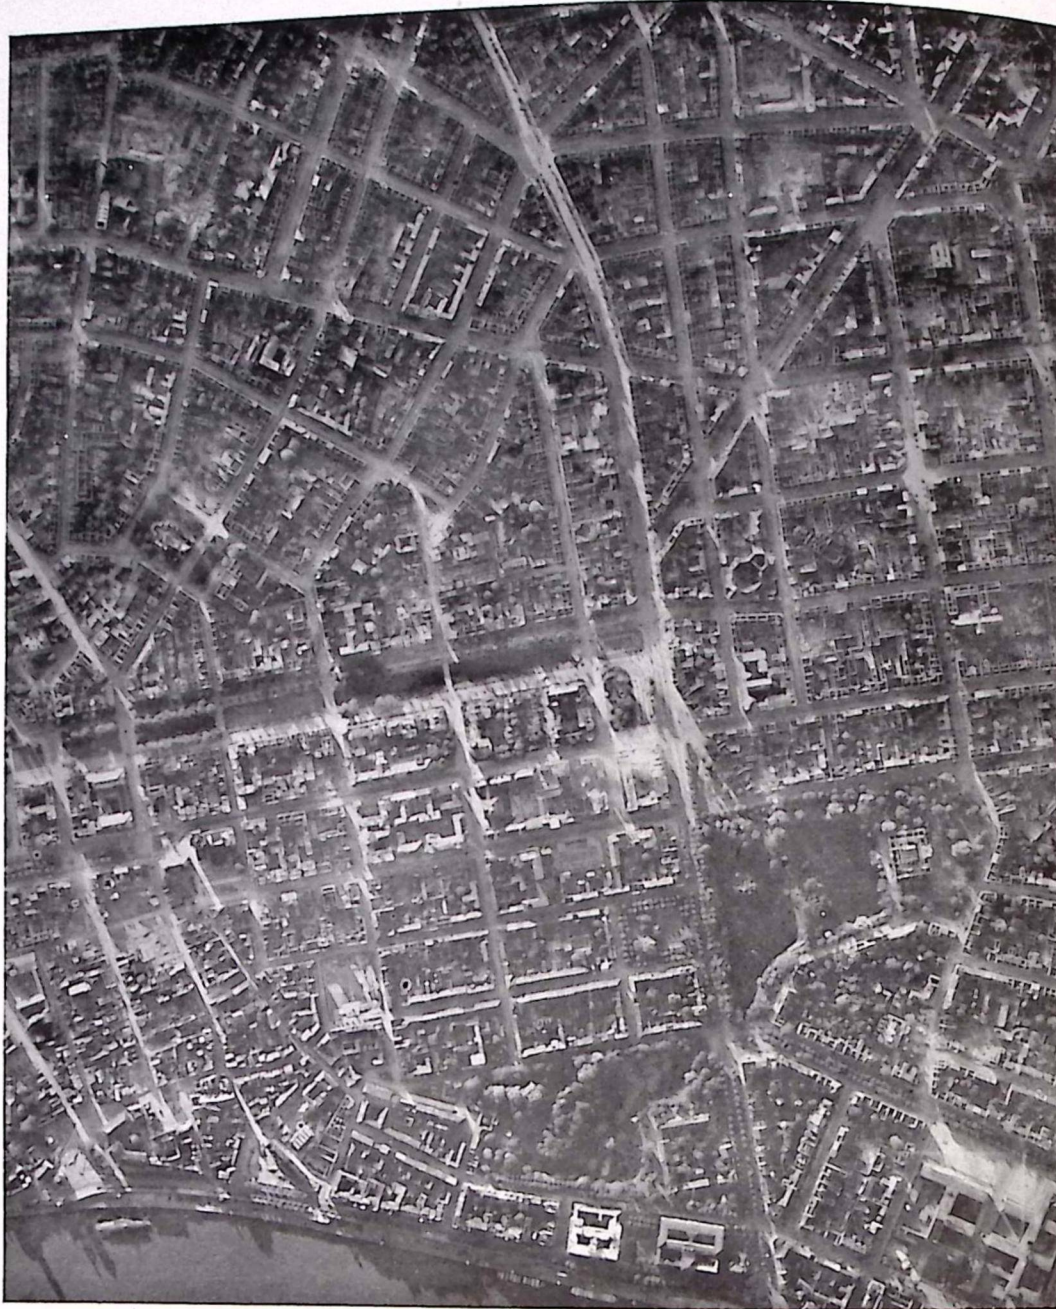
Industrial and residential damage caused in the night attack on DUSSELDORF (11/12.6.43) was extremely heavy and no less than 1,500 acres of devastation is recorded on reconnaissance photographs. The central part of the city lying between the river and the railway suffered severely and this photograph shows a typical area of devastation around Graf Adolf Platz. Many business premises and offices are centred in this closely packed area and despite the broad streets the fires must have been completely out of control.

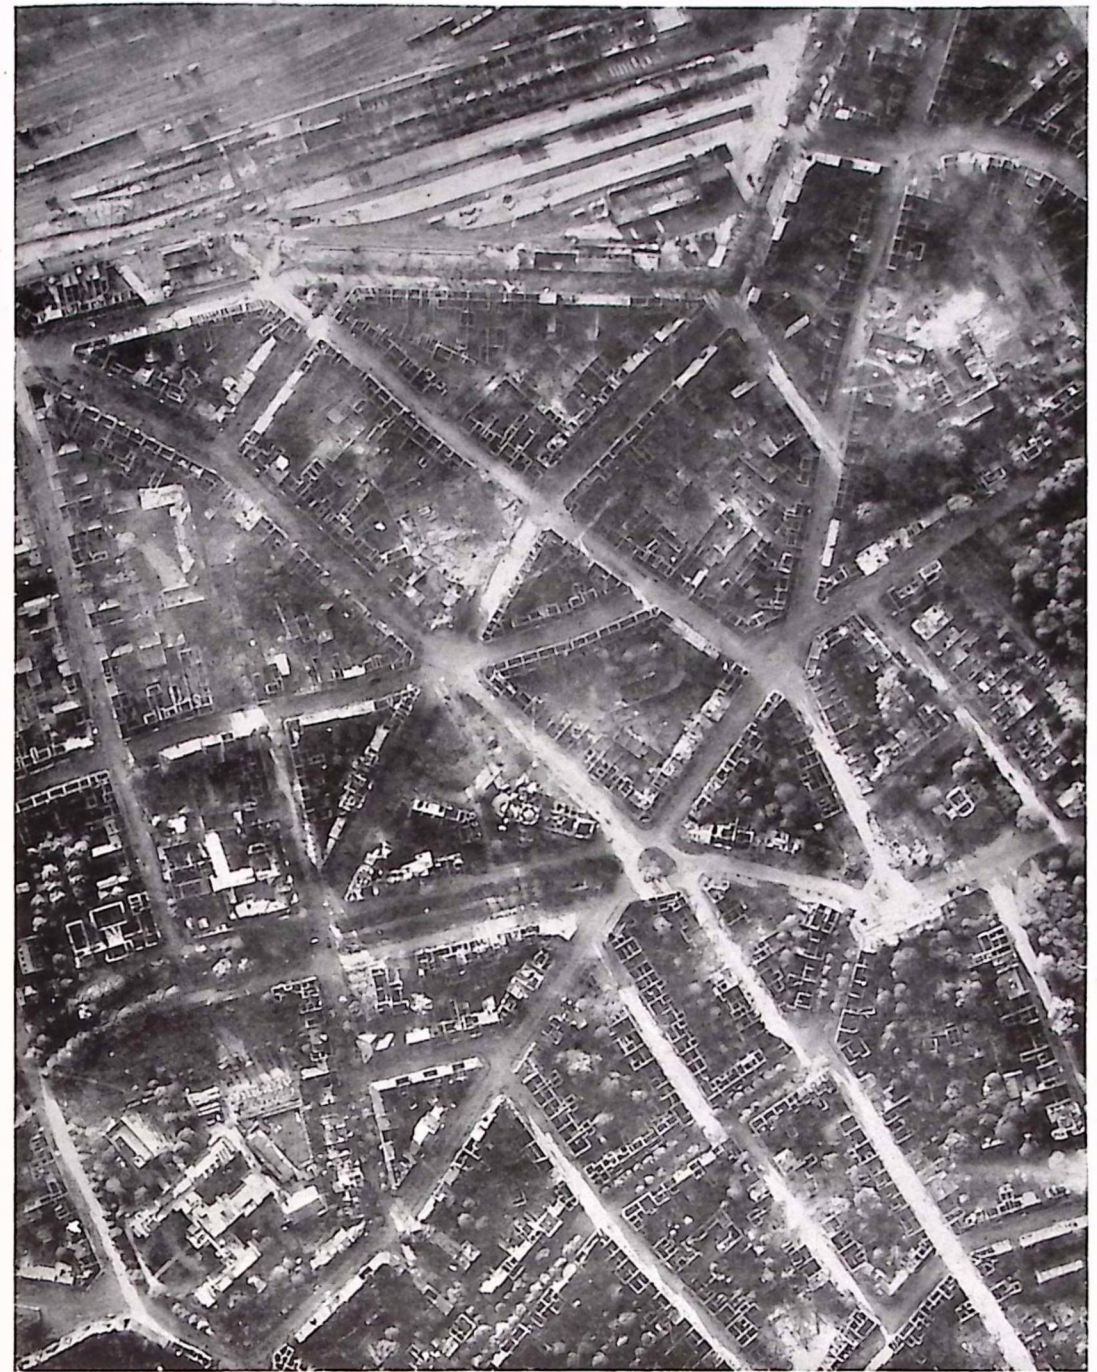
Almost all the transhipment sheds, warehouses and goods station buildings of the marshalling yard at DUSSELDORF/DERENDORF were destroyed. Very few undamaged buildings can be seen in this area of business and commercial premises.

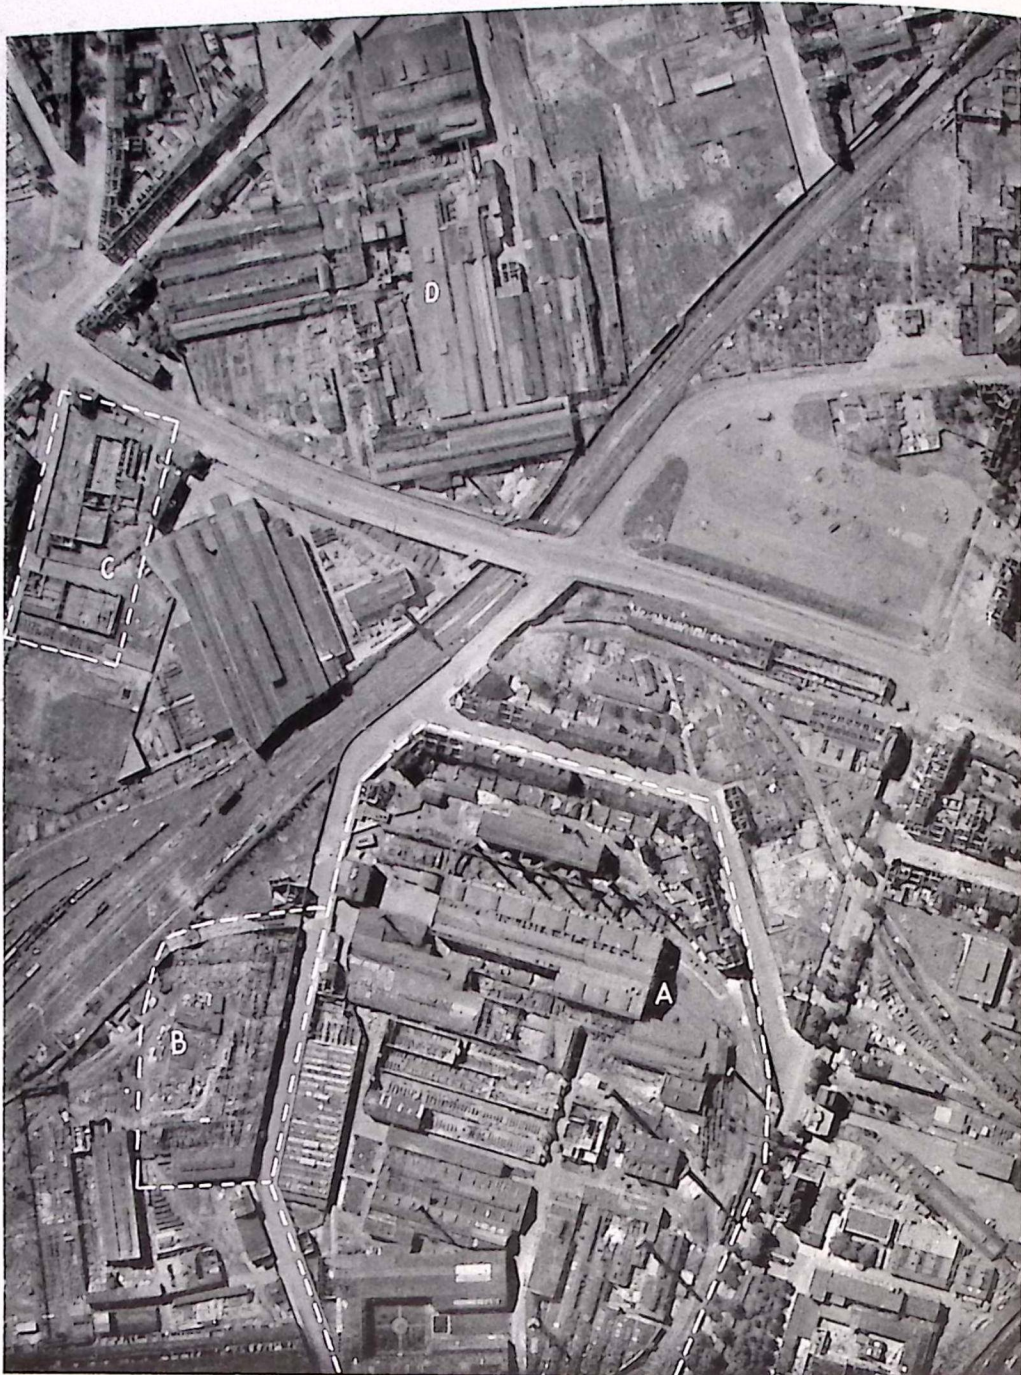
DUSSELDORF. Factories engaged in important war work were also severely damaged. Although part of the damage at Klöcknerwerke A.G., wire products, (A) was sustained previously the major portion was caused in the attack of 11/12.6.43. Other damaged industrial premises include Hein Lehmann u. ver Kesselwerke A.G., boiler engineers, (C) and Deutsche Röhrenwerke A.G., Oberbilk, steel tubes (D), also severely damaged previously.

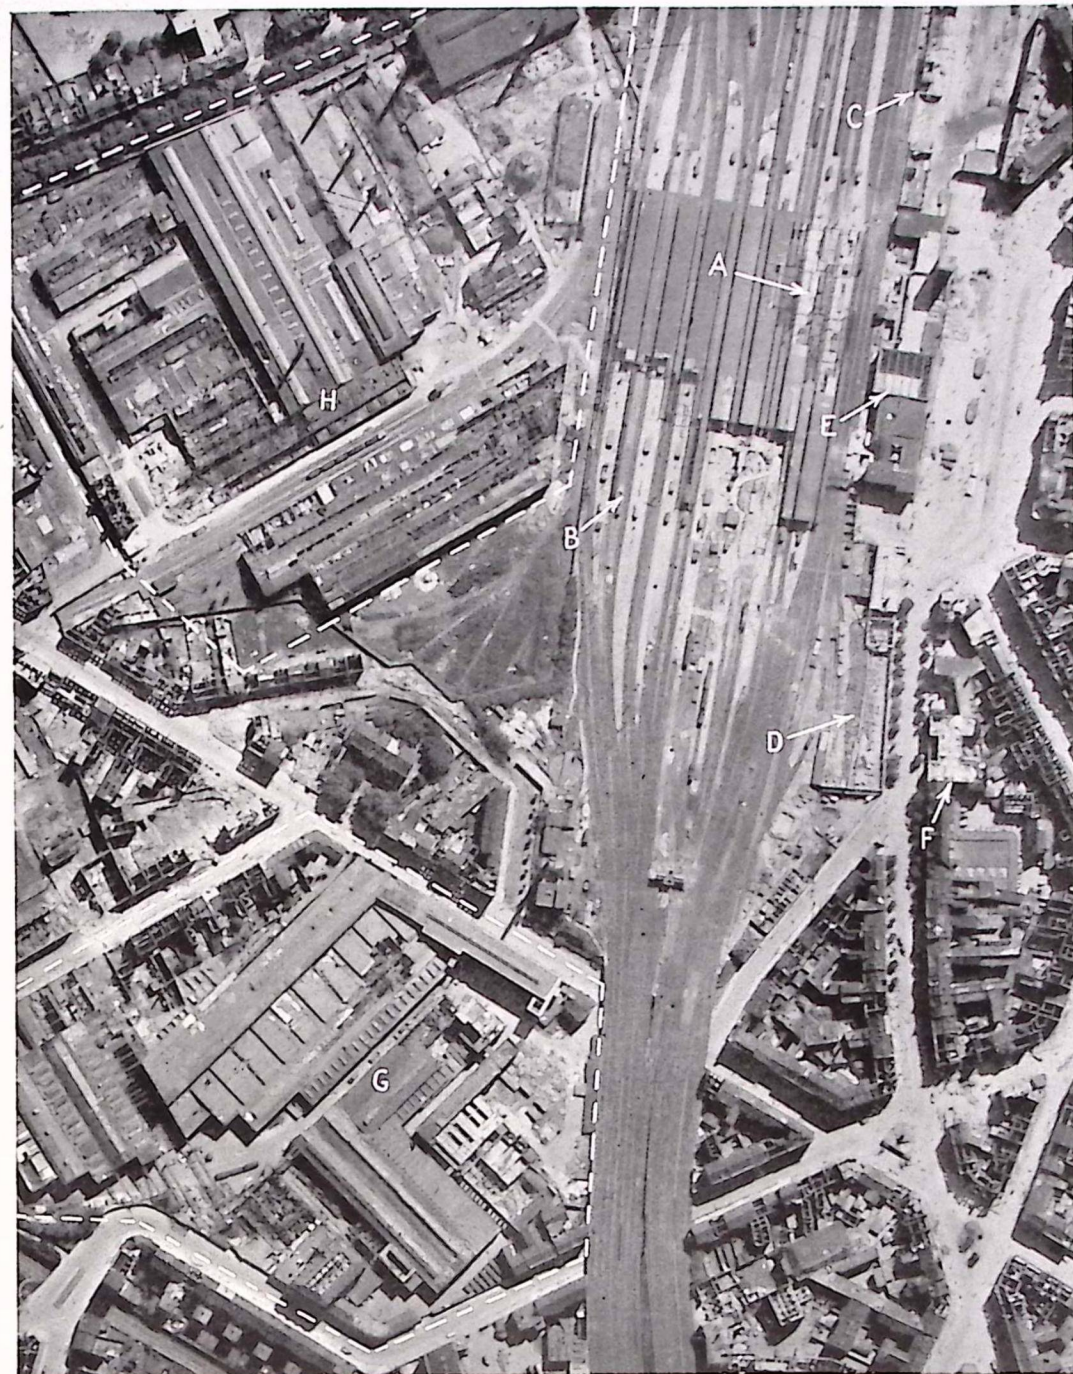
Repairs on the DUSSELDORF Main Railway Station, damaged at (A) by a 4,000 lb. bomb in September, 1942 (See Page 53, Vol. 1, No. 2) and again (B) in an attack early 1943, were incomplete when further hits were made on 11/12.6.43. The Express Goods Depot (C) and the Parcels Office (D) were severely damaged and the Main Station Hall (E) is roofless. Other damaged buildings include the Post Office (F) and the factories of Schiess-Defries A.G., machine tools (G), and Press u. Walzwerk A.G. (H).

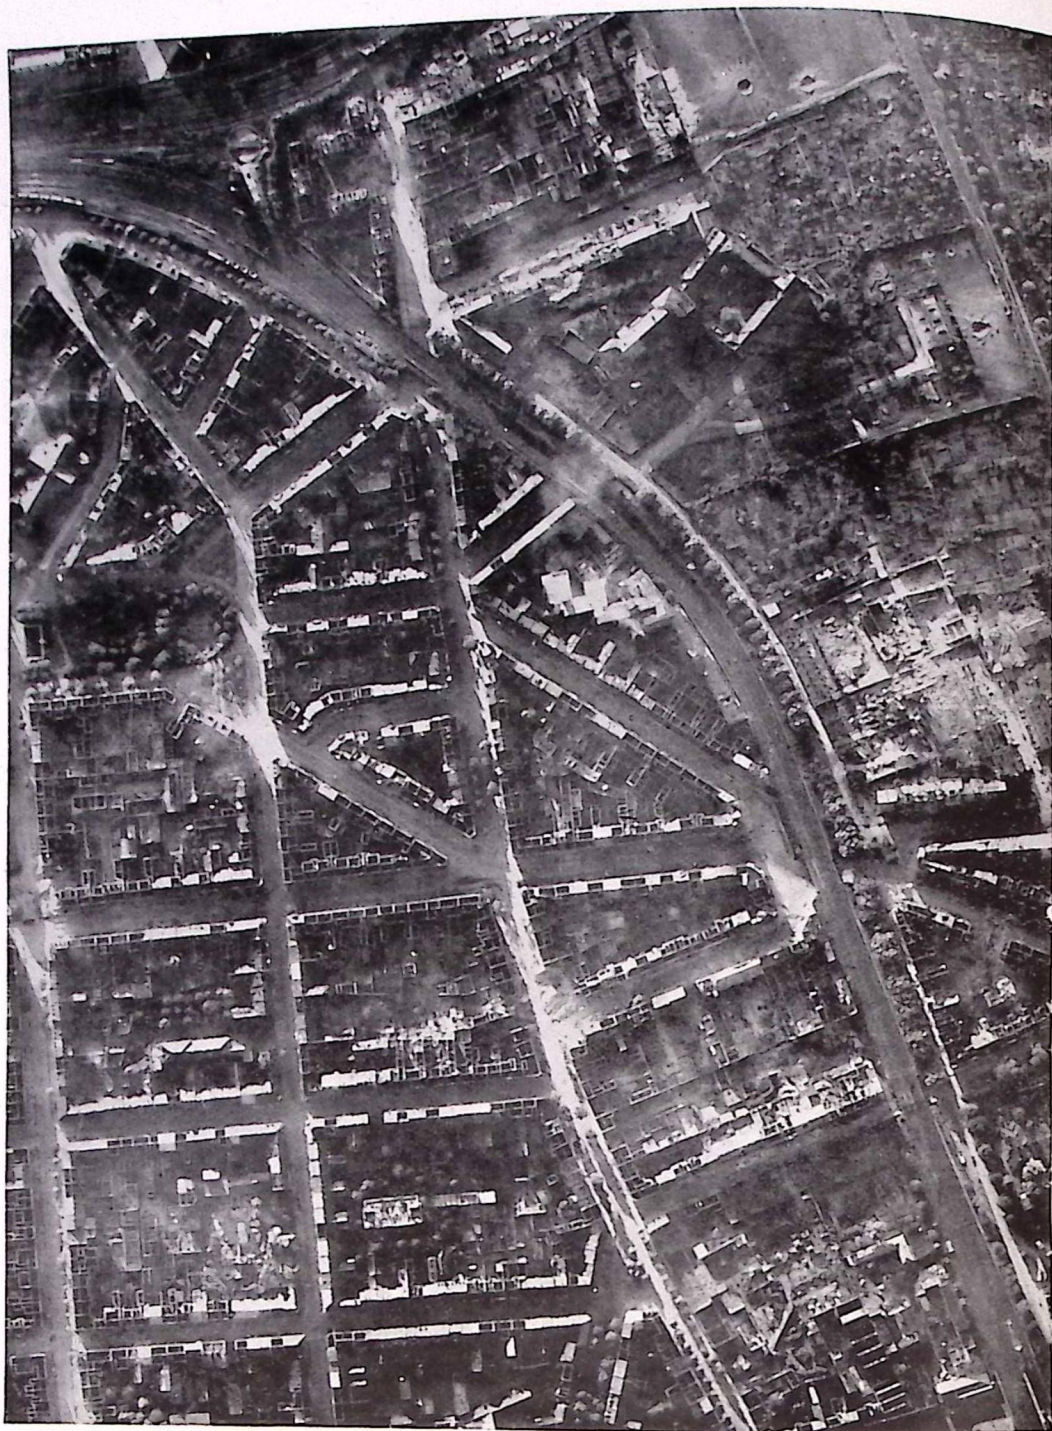
FURTHER DEVASTATION IN DUSSELDORF

Another area of devastation to the south-east of the city where industrial buildings join the business/residential area.

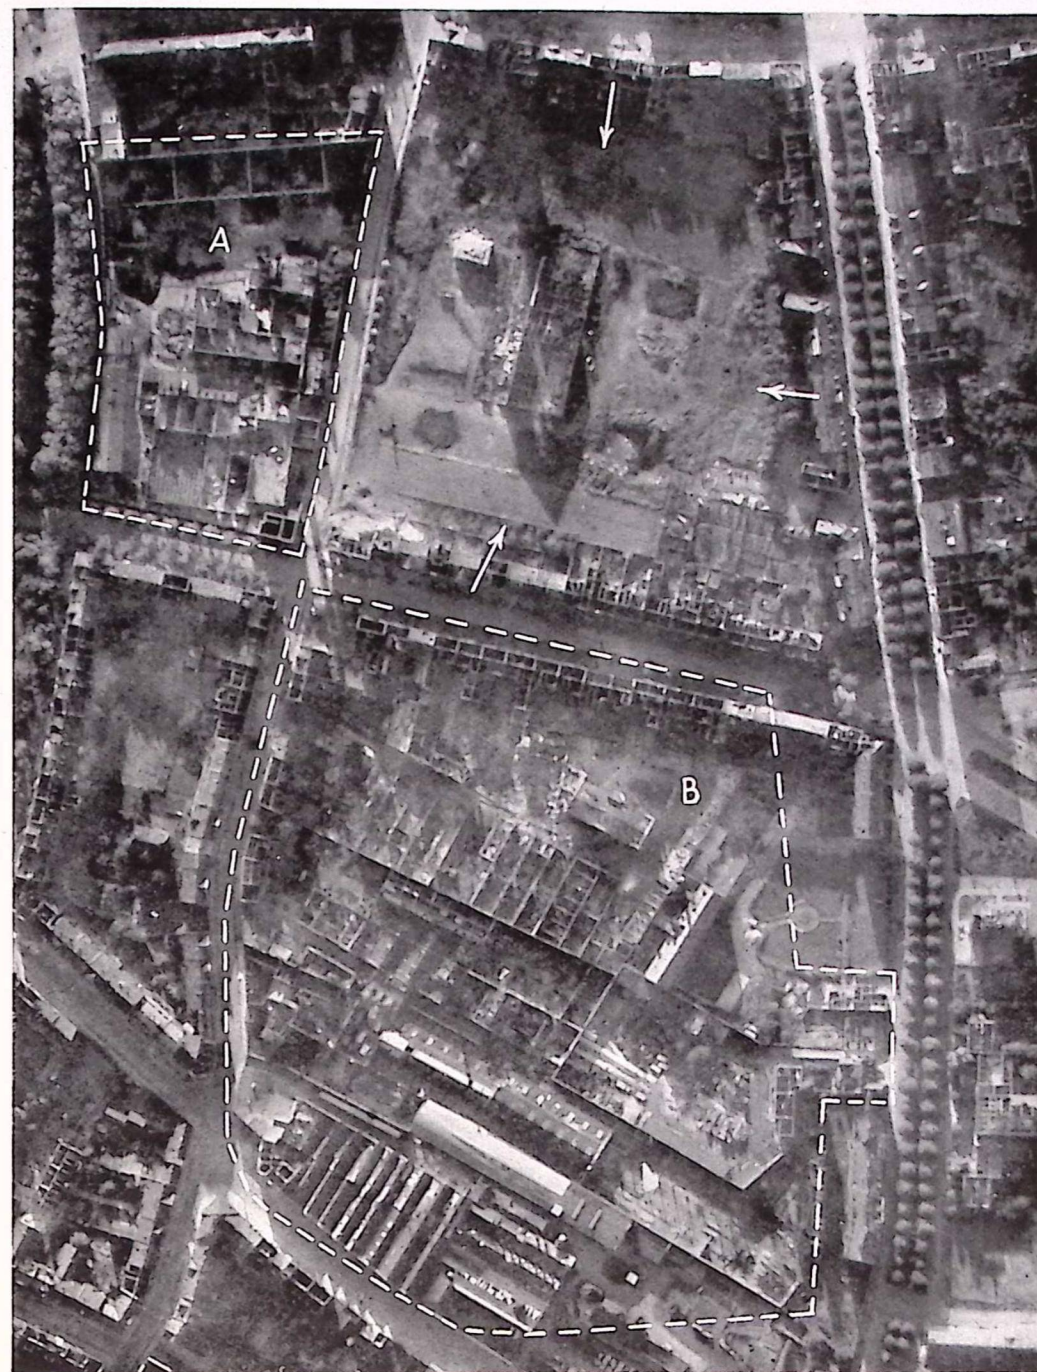
An area to the South of DUSSELDORF (arrows) appears to have been the centre of a large explosion and suggests the site of an explosives store. A large area in the vicinity has been damaged by blast. The paper factory (A) of Schulte u. Zinken at Bilk has been severely damaged, while another large area of damage (B) is seen at and around R. Woeste u. Co. (fittings).

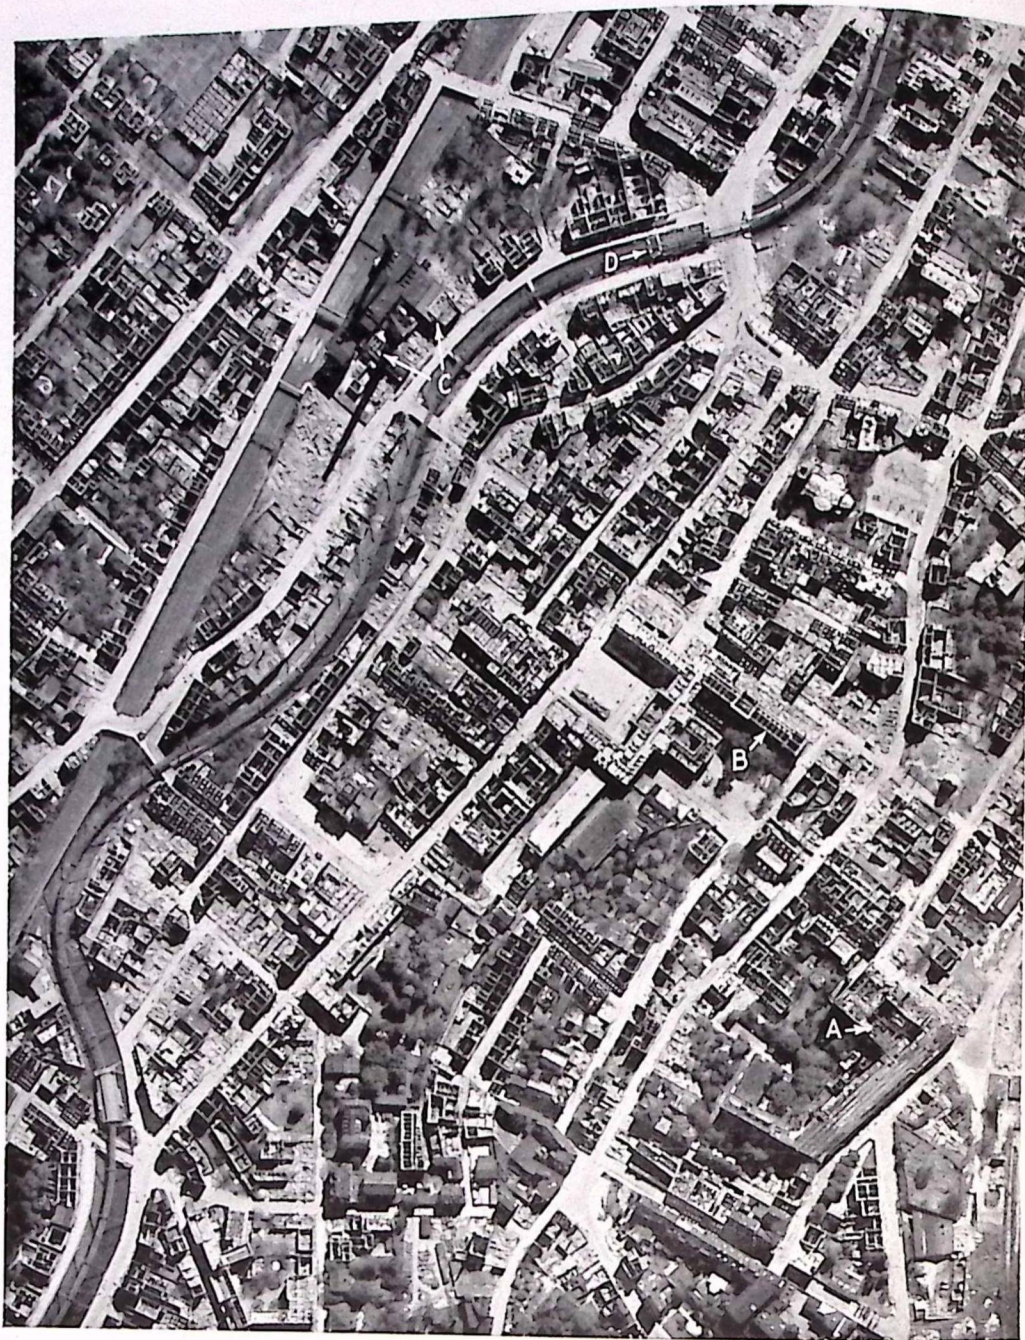
FIRST HEAVY ATTACK ON WUPPERTAL

In the first heavy attack on WUPPERTAL (29/30.5.43) very heavy damage was caused, chiefly in BARMEN where upwards of a thousand acres were devastated. Factories and public buildings were destroyed in this congested valley engaged in producing textiles, small machinery and tools. Among the scores of damaged buildings in Barmen are those of Vorwerk and Co., manufacturers of light machinery (A), the Town Hall (B), the Power Station (C) and the Rathaus Station (D) on the Overhead Railway.

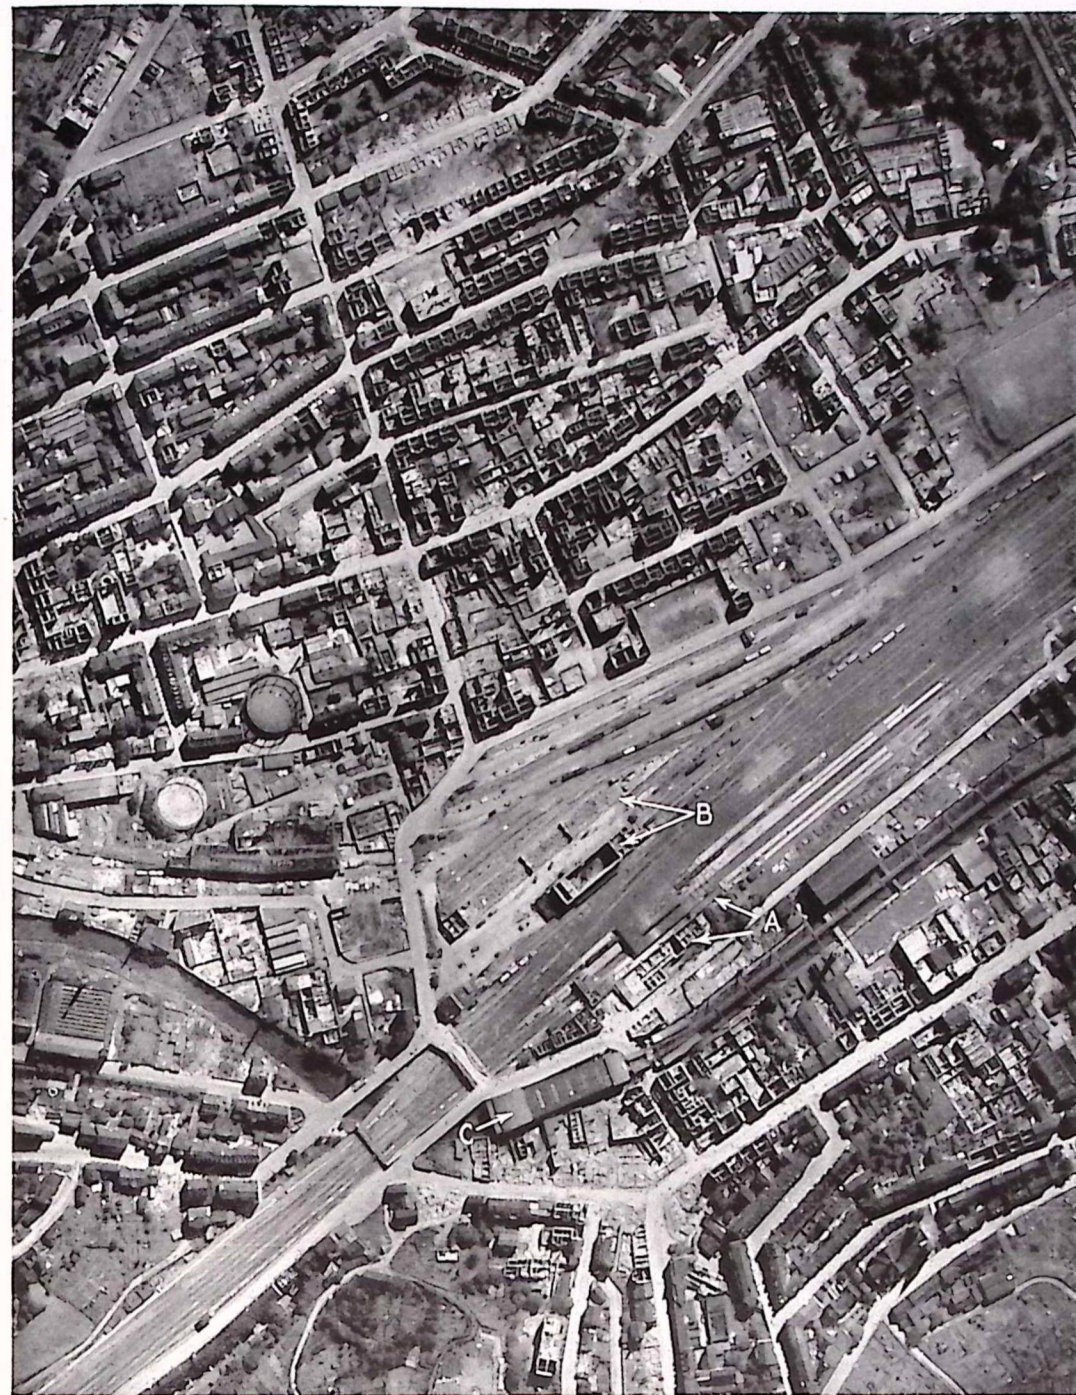
FACTORIES DAMAGED IN CONGESTED VALLEY

BARMEN-RITTERSHAUSEN Railway Station was devastated. The Passenger Station (A) and Goods Station (B) have been wrecked and numerous small factories are included in this large area of destruction. The terminus of the Overhead Railway (C) is surrounded by the shells of buildings.

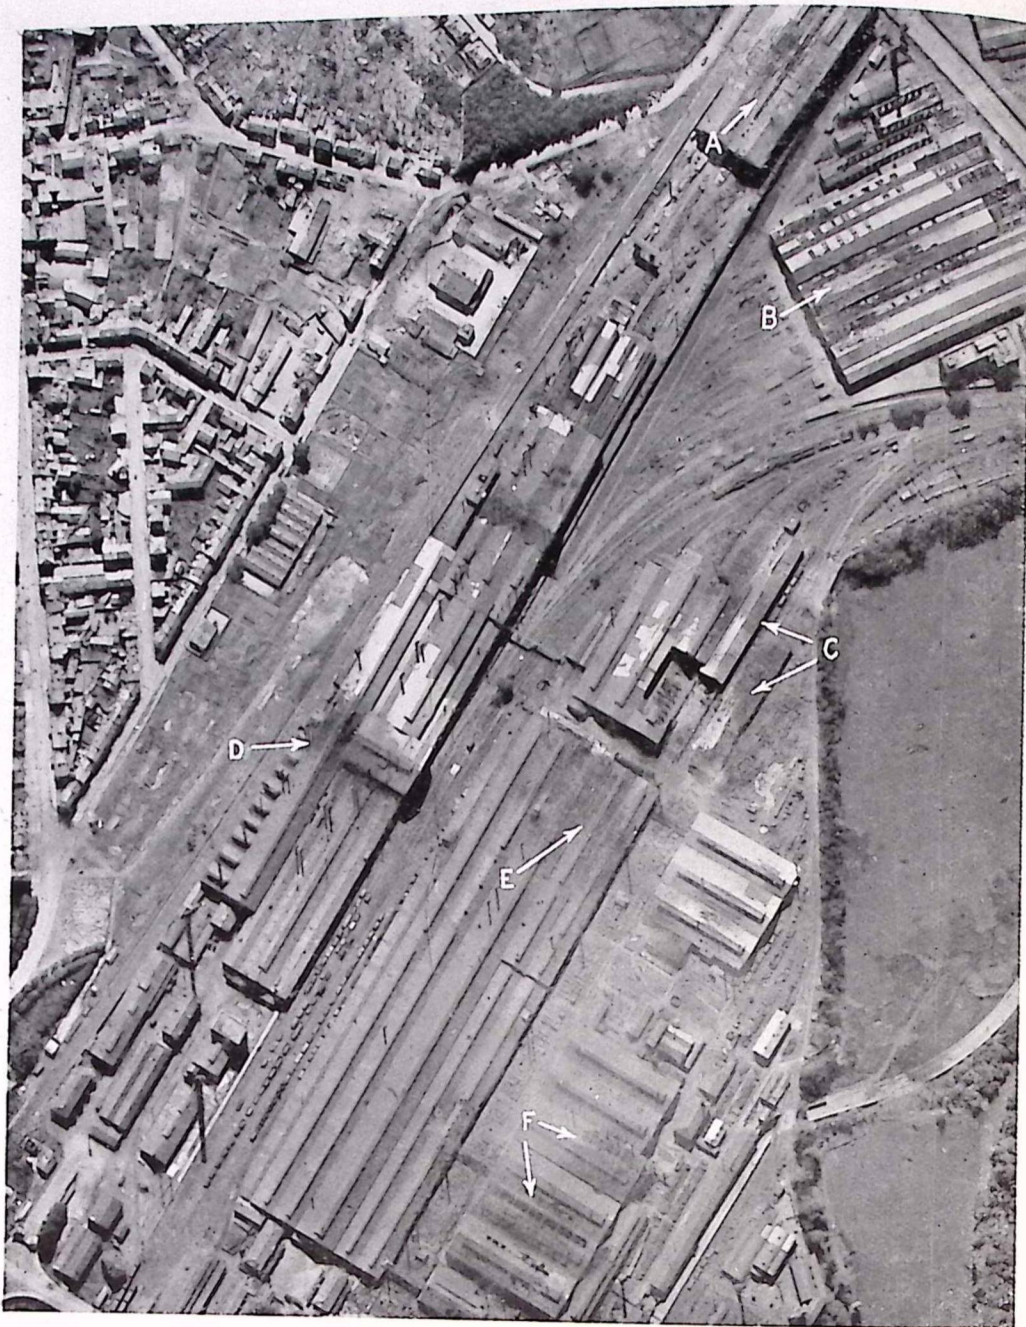
LE CREUSOT STEELWORKS SEVERELY DAMAGED

More than thirty medium or large buildings of the armament and locomotive works of Schneider et Cie, LE CREUSOT, were damaged in the R.A.F. attack on 19/20.6.43. At the Processing Works, the Forging Shop (A) and Turbine or Tank Construction Shop (B) were extensively damaged by H.E. The Bar Stores and other buildings (C), damaged in the previous R.A.F. attack, were destroyed or badly damaged. Other seriously damaged workshops included the Heavy Forging Department and Armour Plate Bending Shop (D) and Rolling Mills (E and F). Damage to the two Rolling Mills covers an area of approximately 14,000 sq. yds.

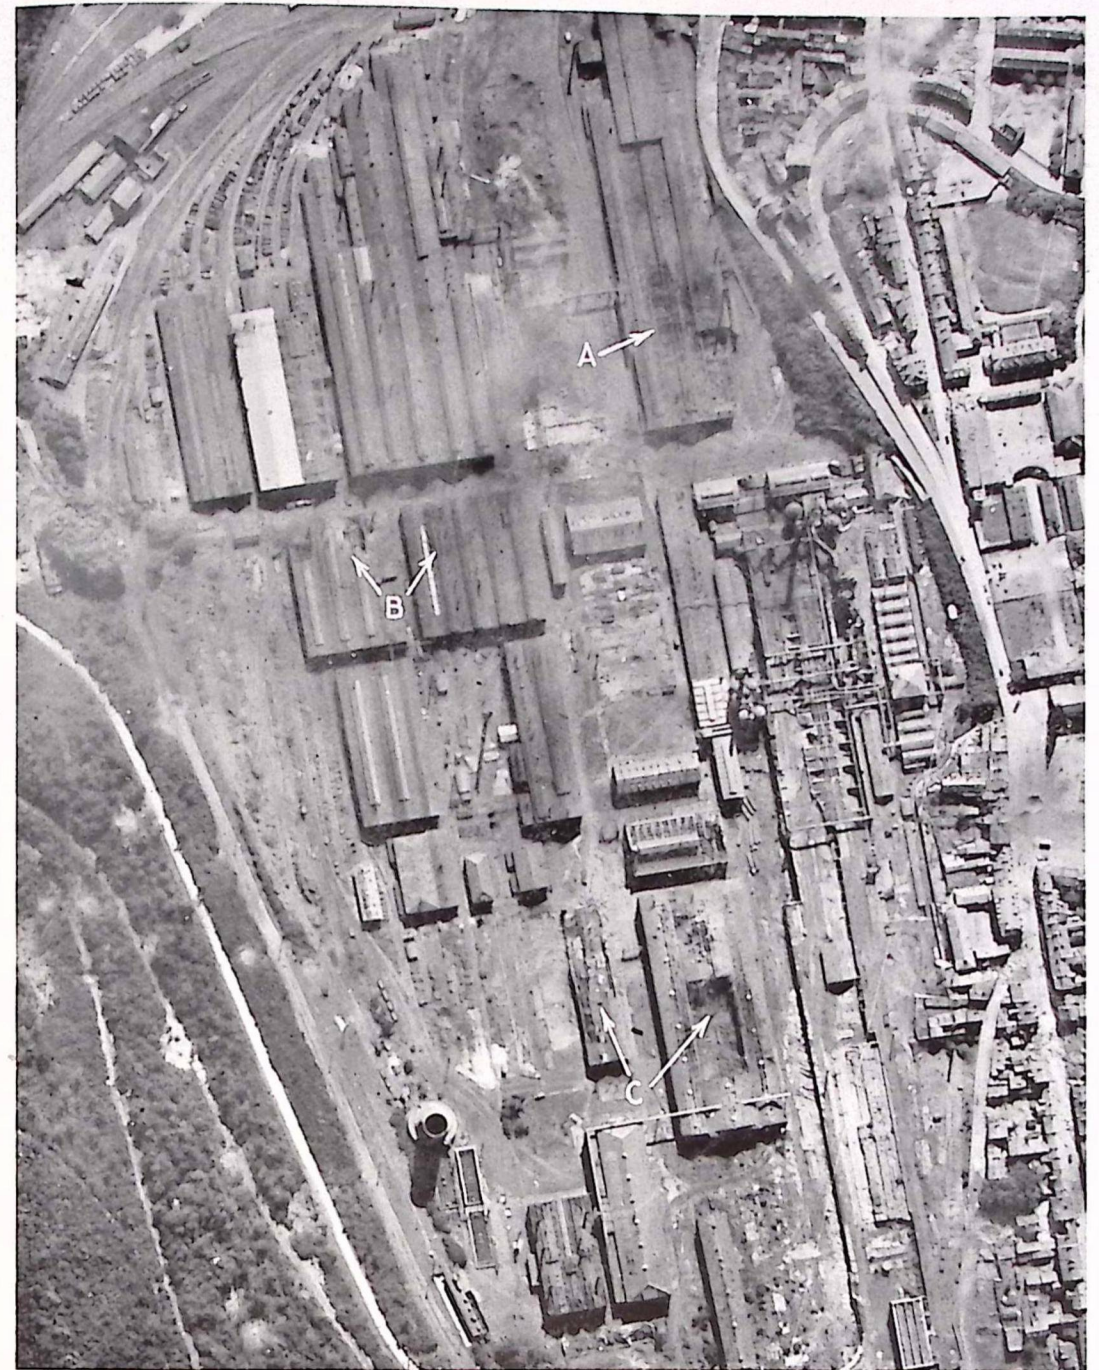
The main building (A) of LE CREUSOT Steelworks was damaged by direct hits over an area of 4,000 sq. yds. while the Light Forging Shops (B) were also hit. The Boiler and Locomotive Shops (C) were wrecked over approximately 75 per cent. of their combined area; other buildings are razed and still burning.

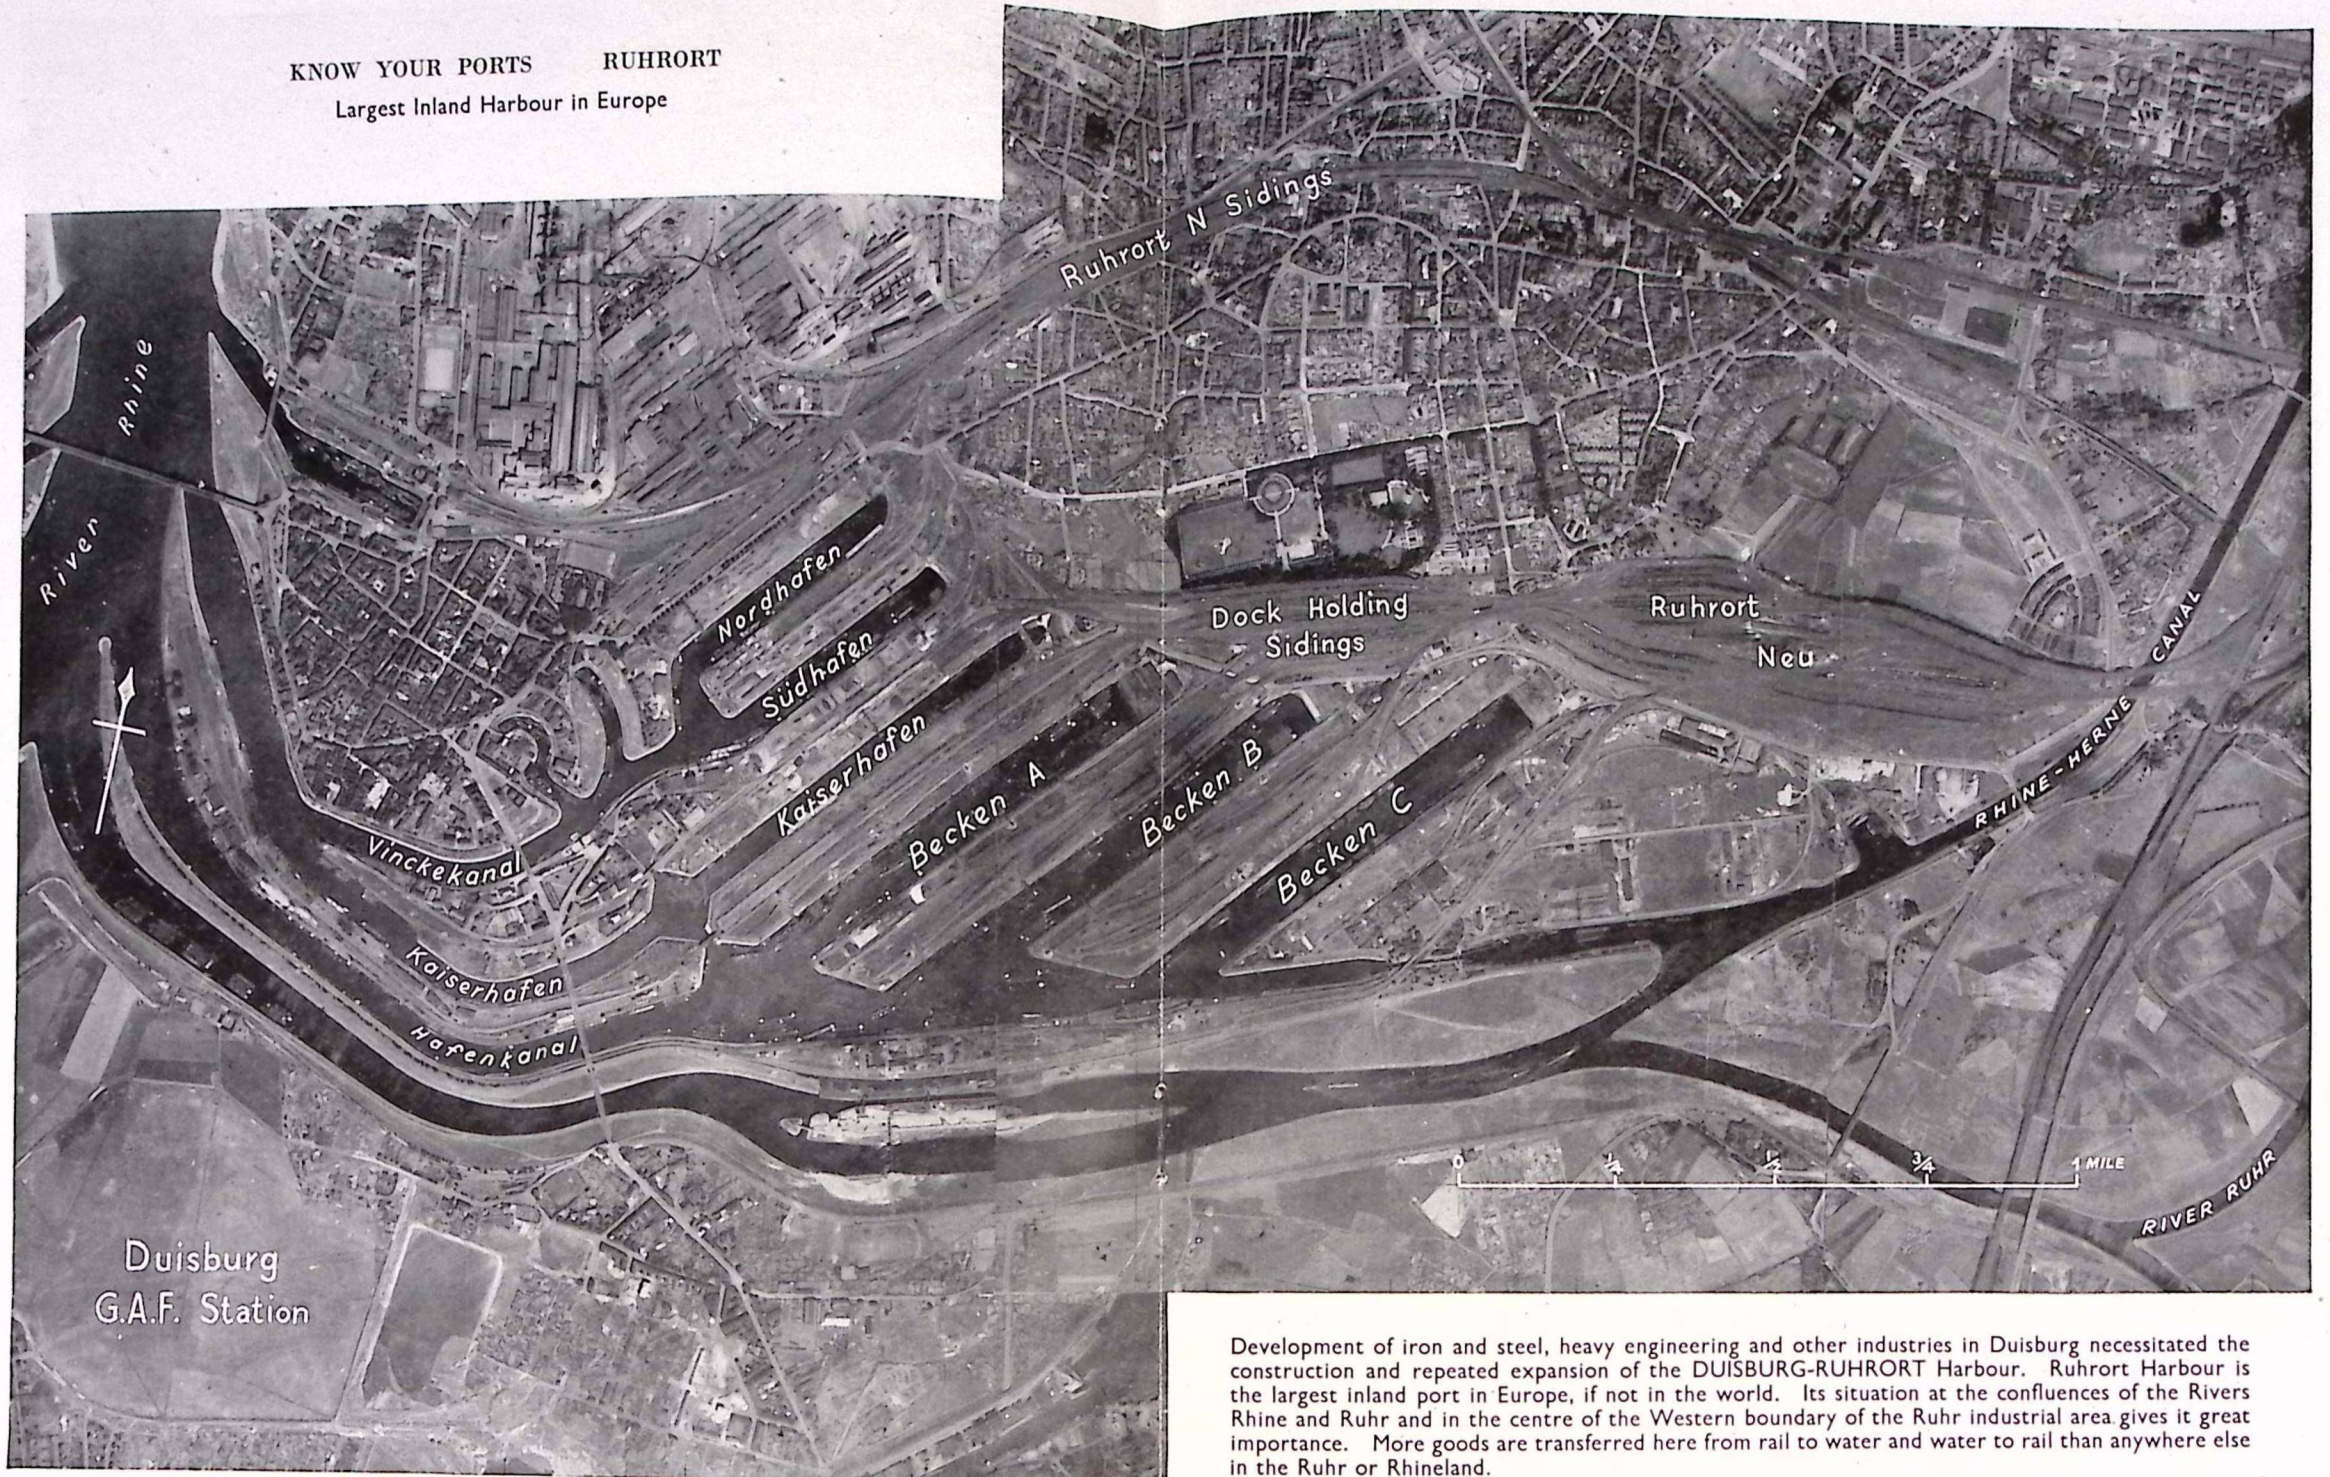
KNOW YOUR PORTS RUHRORT
Largest Inland Harbour in Europe

Development of iron and steel, heavy engineering and other industries in Duisburg necessitated the construction and repeated expansion of the DUISBURG-RUHRORT Harbour. Ruhrort Harbour is the largest inland port in Europe, if not in the world. Its situation at the confluences of the Rivers Rhine and Ruhr and in the centre of the Western boundary of the Ruhr industrial area gives it great importance. More goods are transferred here from rail to water and water to rail than anywhere else in the Ruhr or Rhineland.

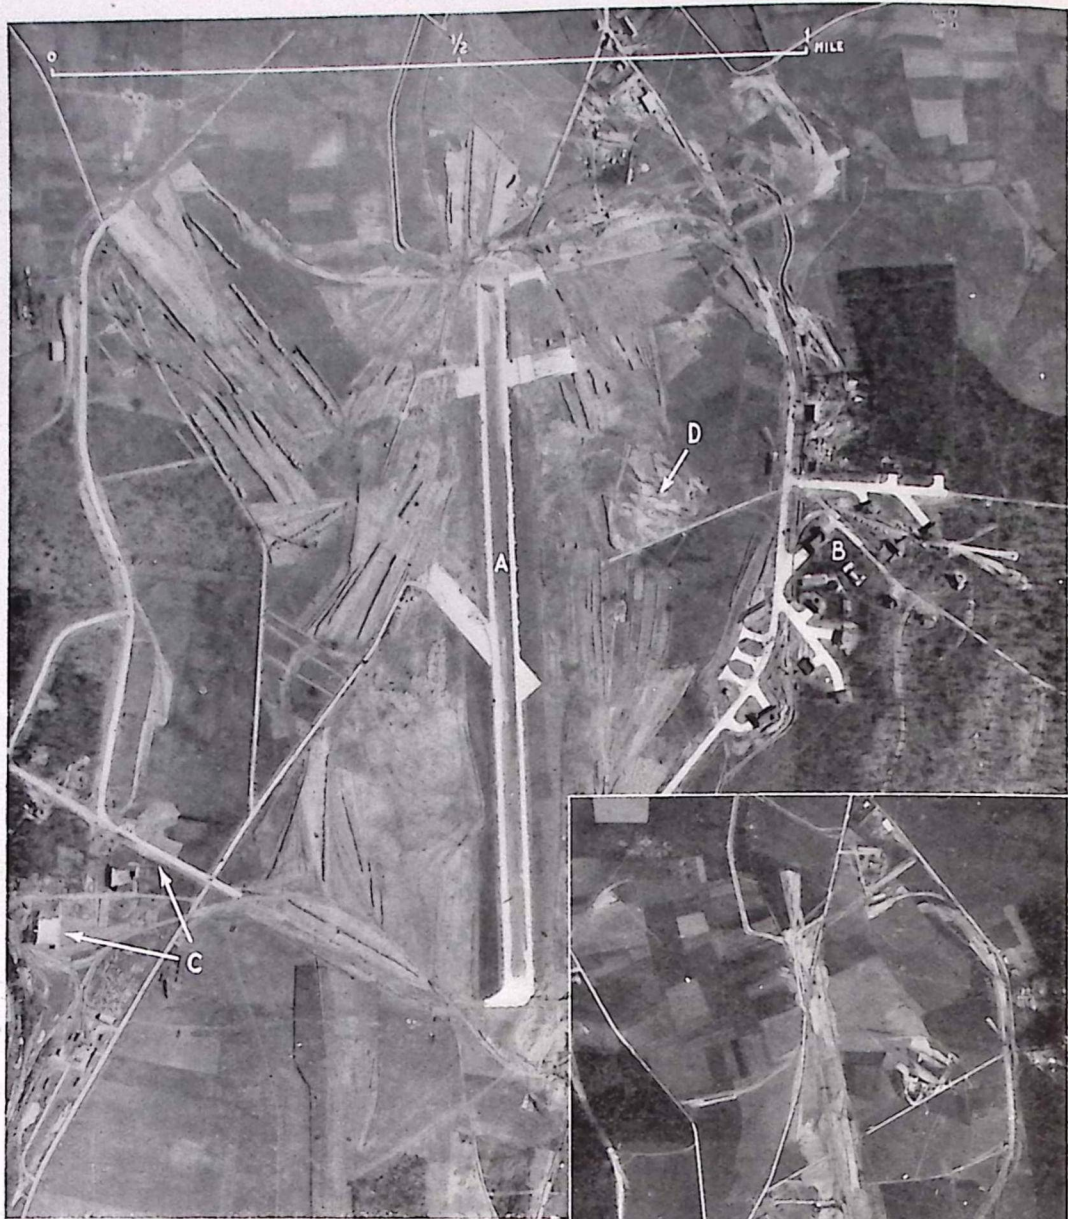
NIGHT FIGHTER AIRFIELD DEVELOPMENT

Constructional work on this airfield near FLORENNES, Belgium, has been extensive during the past nine months. Inset photograph shows construction in an early stage. A few months later considerable progress has been made. The runway (A) had been completed and two additional runways were being prepared. A dispersal area (B) was under construction with villa type shelters. Surfacing of perimeter track and construction of a large hangar (C) had also taken place. A quarry (D) has been filled in with spoil excavated from the runway sites.

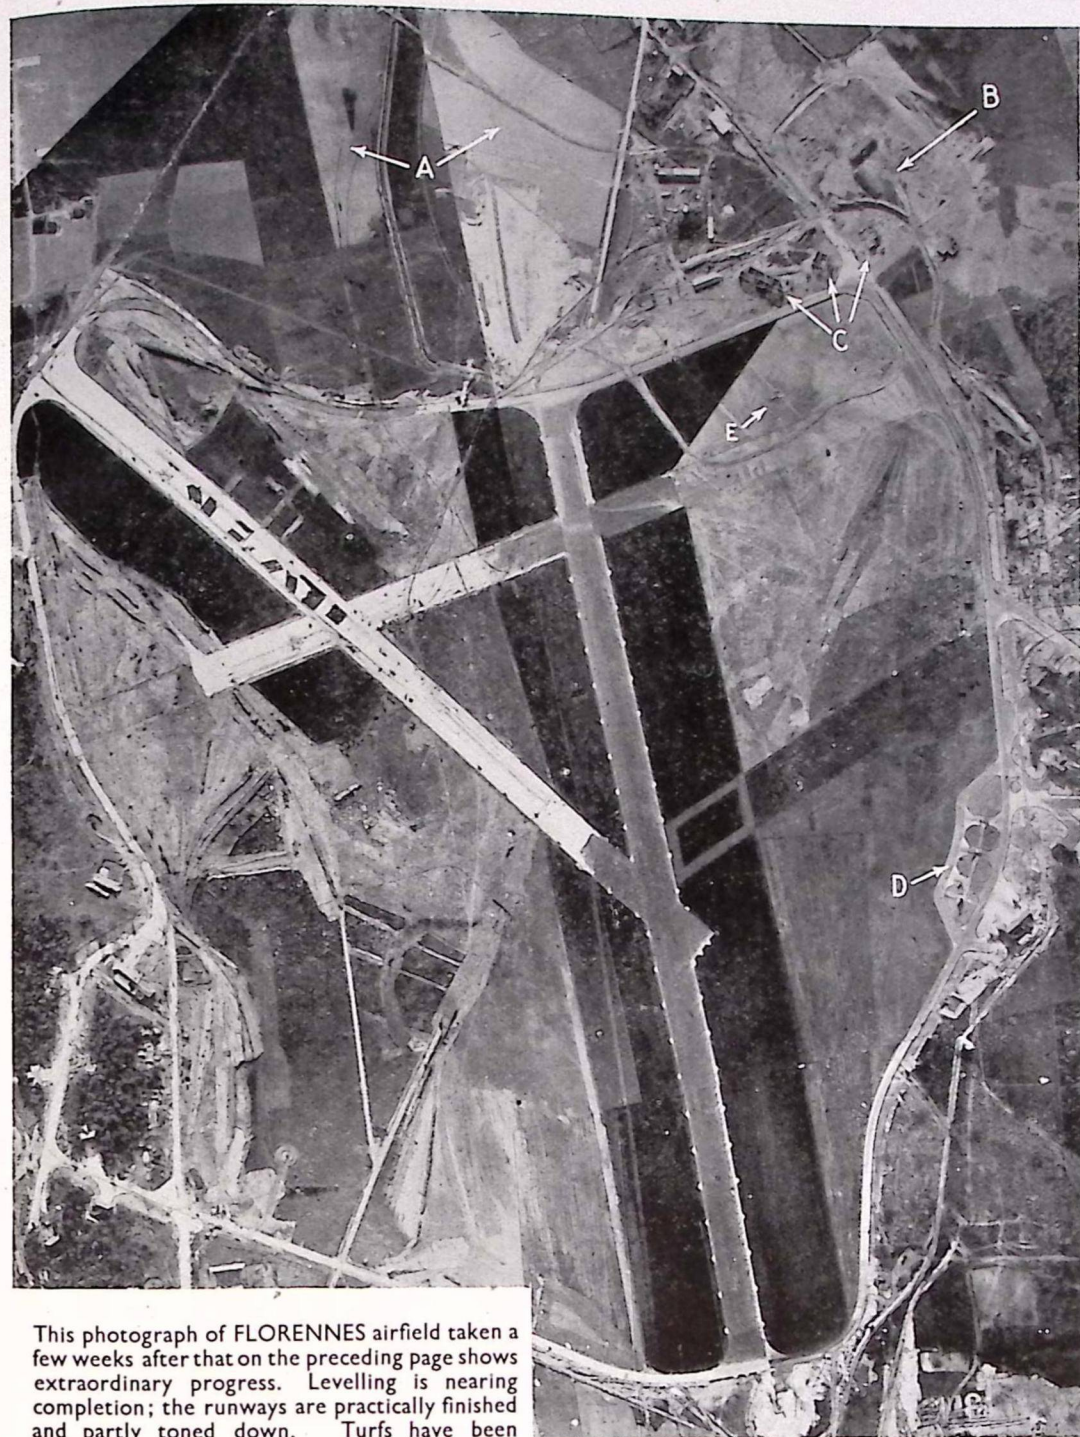
This photograph of FLORENNES airfield taken a few weeks after that on the preceding page shows extraordinary progress. Levelling is nearing completion; the runways are practically finished and partly toned down. Turfs have been removed from adjoining fields (A) to make a grass surface for the landing area. An additional dispersal area (B) is being prepared and constructional details of the villa type hangars (C) can be seen. A number of Me. 110s parked on the now complete servicing tarmac (D) and elsewhere show that the airfield is already in use. (E) Crashed Dornier aircraft.
