Issued by
AIR MINISTRY A.C.A.S.(I).

VOLUME 4

JULY 5TH 1943

EVIDENCE IN CAMERA

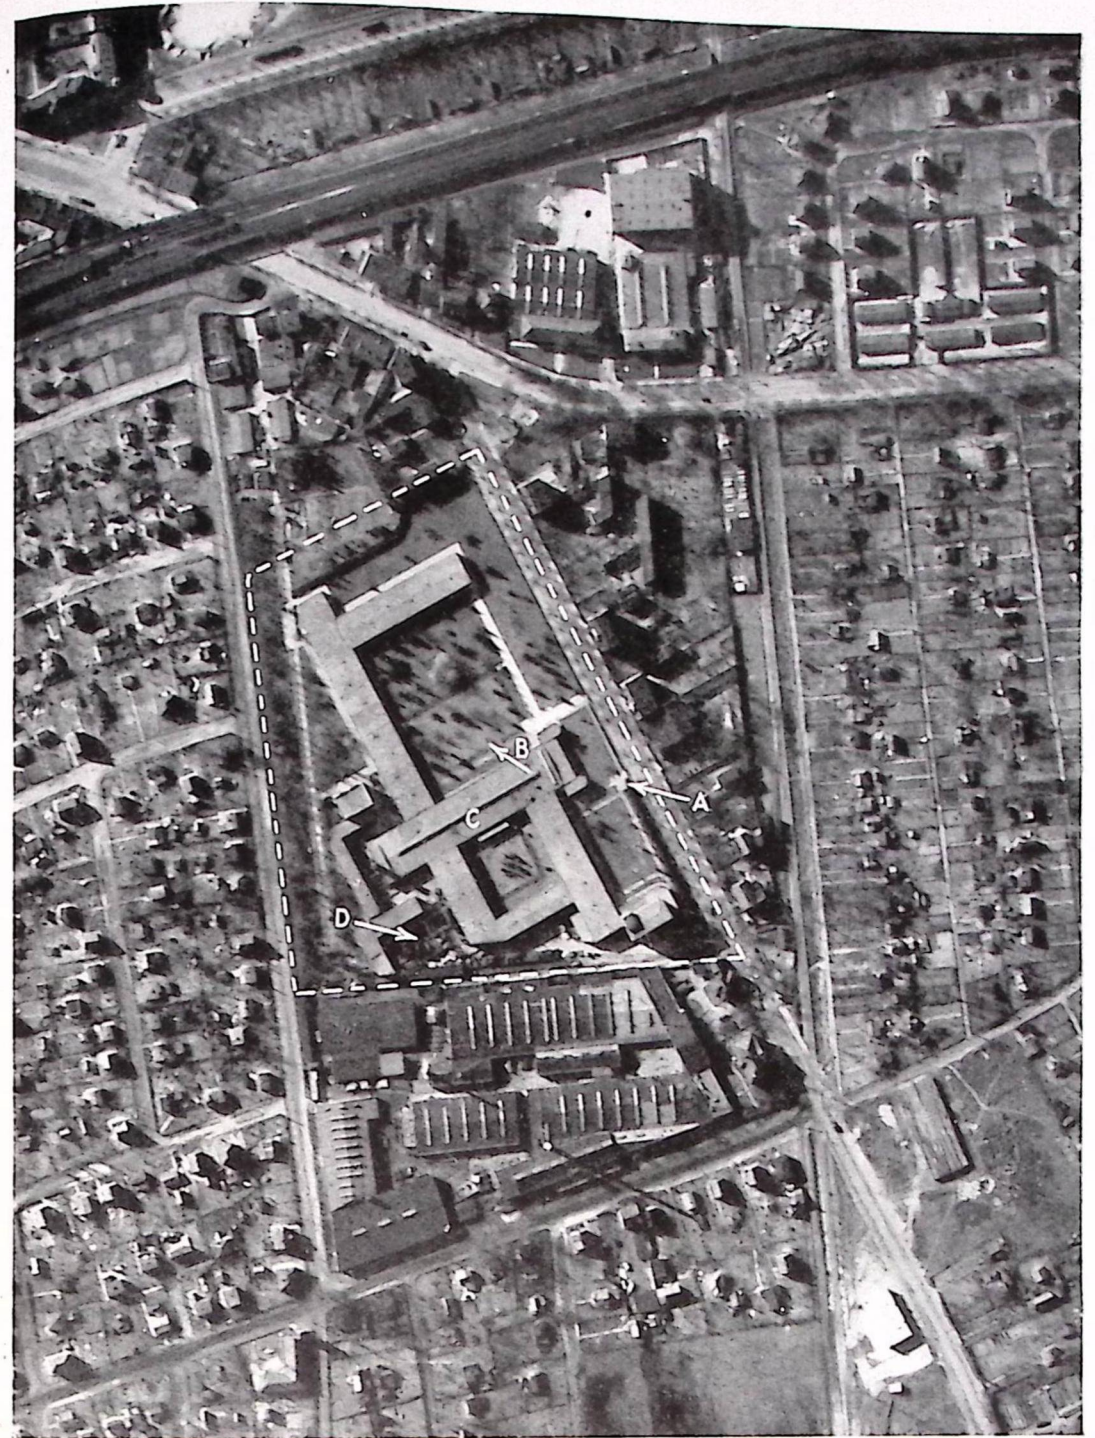
Herbert Lindner Factory, BERLIN

Considerable additions have been made to the original plant (C) since the photographs on the opposite page were taken. The gantry crane and loading bay adjoining the railway sidings are visible at the stockyard (D). The jig boring equipment manufactured at the factory is vital to the German aircraft industry.

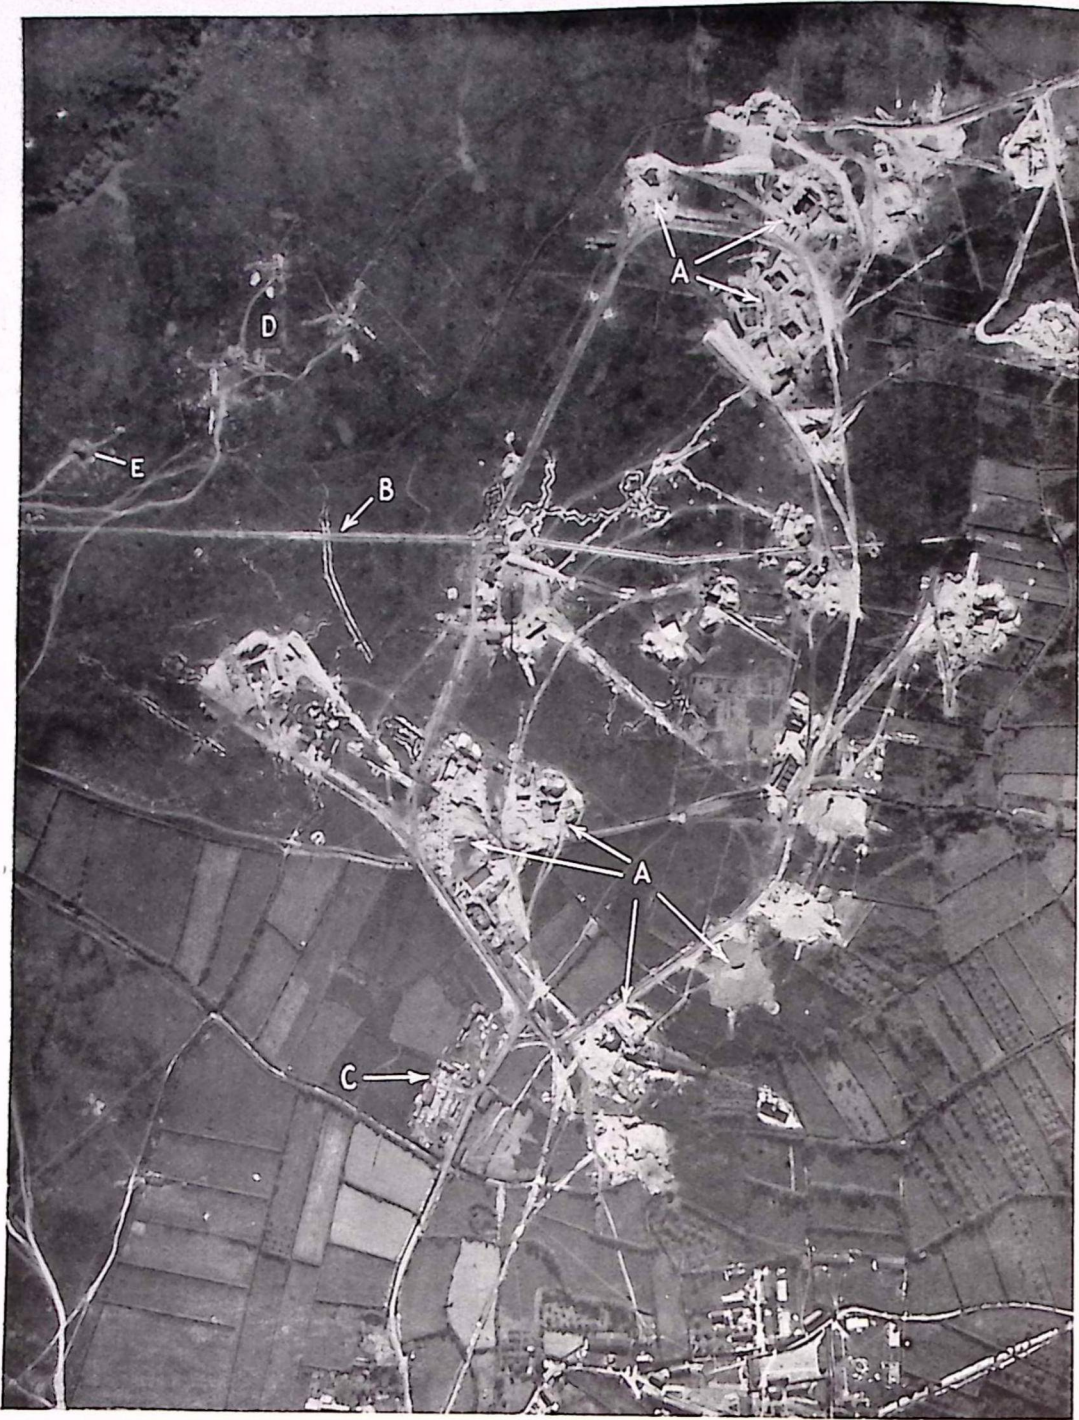
Considerable construction of coastal defences is taking place at MAUPERTUS, near CHERBOURG. These defences, serviced by a light railway, include numerous concrete casemate shelters (A) in various stages of construction, cable trench (B) and a stores dump (C). There is also a three gun light flak position (D) and a 60 cm. searchlight (E).

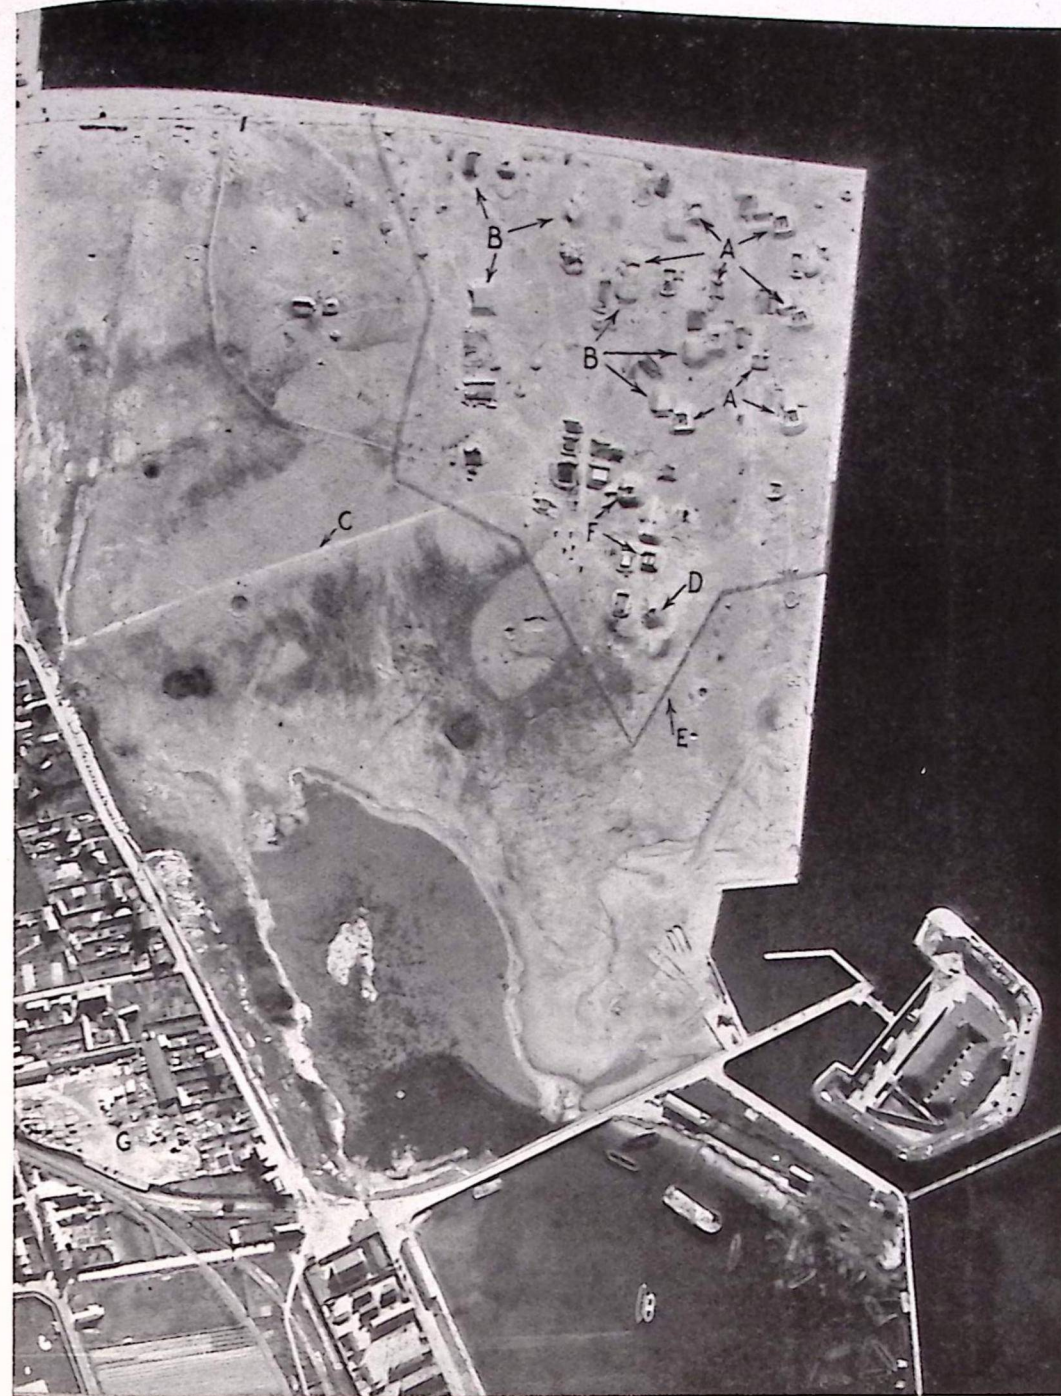
An eight gun A.A. Coastal Defence battery has been constructed on CHERBOURG Quai. Gun emplacements (A), three unoccupied, have been built on top of concrete shelters. Further concrete shelters (B) are for personnel, ammunition, etc. The gun positions are joined by cable trenches (C) and the whole position is defended by light flak (D) and wire (E). Further installations include R.G.L. (Radio Gun Laying) shelters (F) and a stores dump (G).

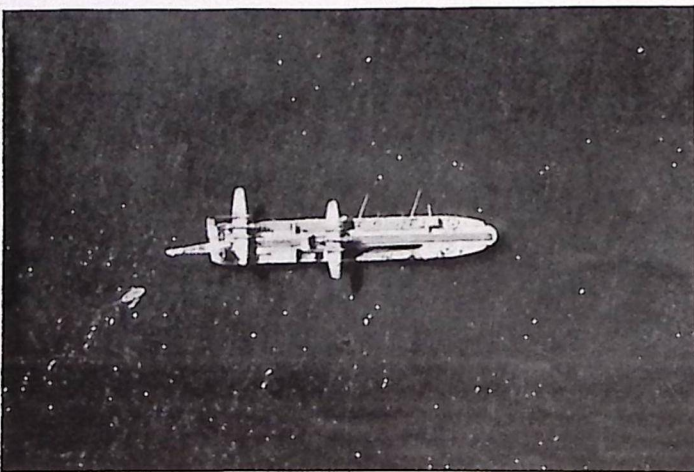
Top: OSTMARK I (243 ft. o.a.). The catapult on the centre line extends about four-fifths of the ship's total length. Note the square gun positions on each side of the catapult.

There are five catapult ships in the German Navy. Three of these have been specially built and two are converted merchantmen. The Germans use these ships in Northern waters probably to catapult reconnaissance aircraft from them. A crane is usually carried at the after end of the catapult.

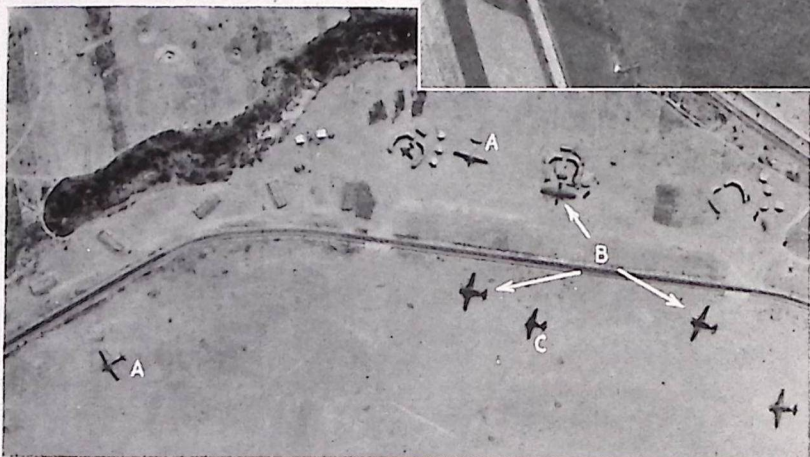
G.12s (A) are fairly frequently seen at Italian air bases. The other aircraft are S.M.82s (B) and an S.M.81 (C).

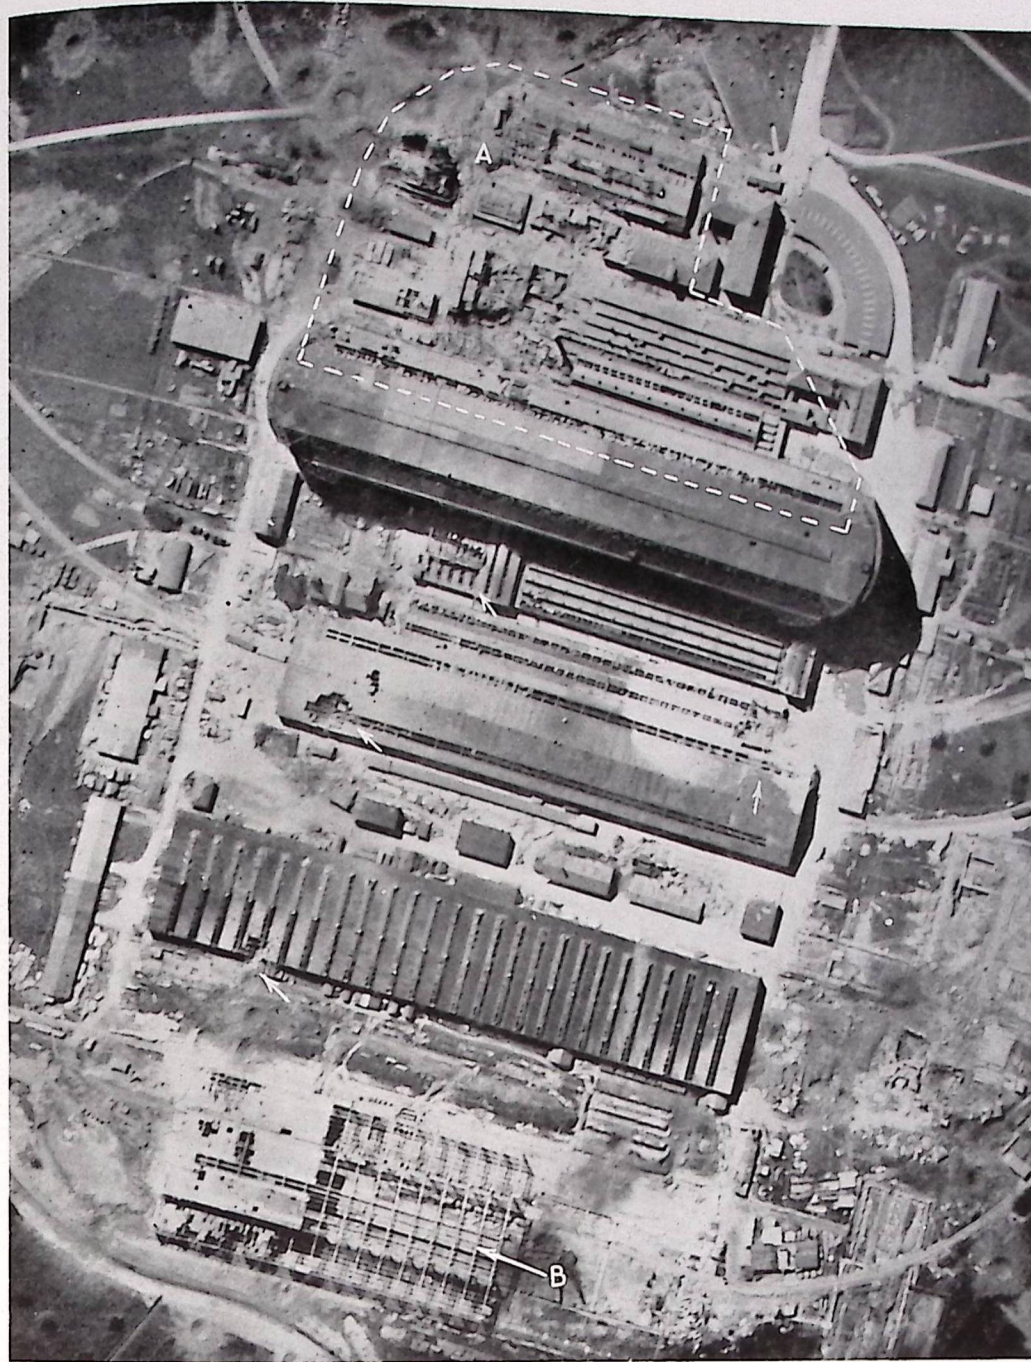
The important light metal casting works of Luftschiffbau Zeppelin G.m.b.H., reported to be making wireless components and mines, were severely damaged by H.E. bombs in the attack on FRIEDRICHSHAFEN by Bomber Command on 20/21.6.43. An area (A) of about three acres was devastated and there was damage to the giant hangar in which Zeppelins were formerly built. Direct hits and near misses caused extensive damage to other large buildings, including that under construction (B).
